Powder Cure Oven Upgrade

08/12/07

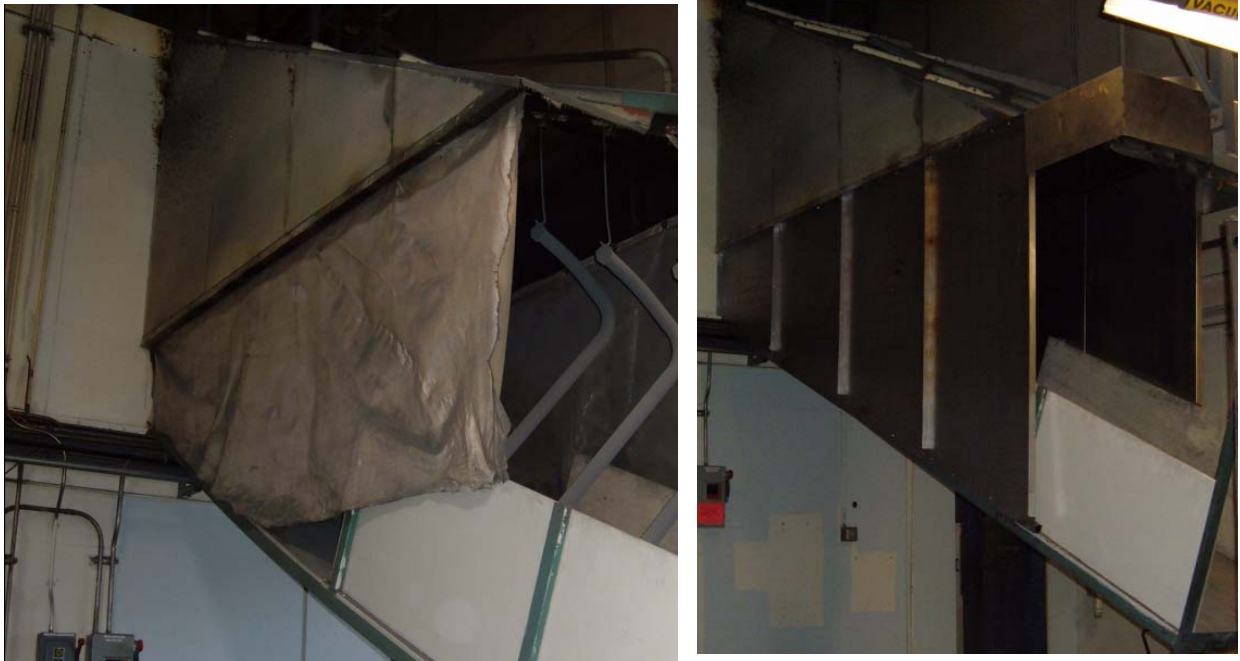
The vestibules on the machine were allowing air to enter the chamber and a significant heat balance problem existed both inside the oven and in the plant where the heat and fumes influenced the work environment in the plant.

The left picture shows the old vestibules with cloth sealing of the entry ways to the oven. On the right hand picture is the new sheet metal added including a hood which will be connected to the outside.

Bogh Industries installed as a turn key project. The plants maintenance personnel also provided help installing new burner and burner train plus two new vestibules and a modification to the last vestibule by replacing the cloth materials with sheet metal. Three new pieces of duct were installed inside the oven to eliminate a 120F uniformity problem. Balancing dampers were also installed to be able to better balance the oven's airflow.

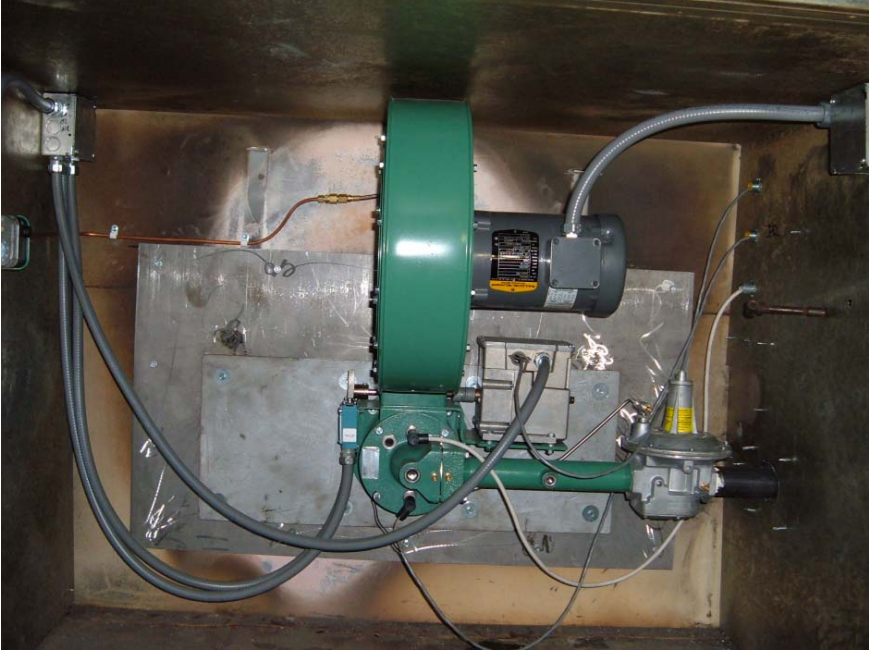
The new burner installed and repairs to the outside wall completed.

The new burner heated the oven up faster than the old and uniformity was improved to a state such that the line speed could be increased by 20-30%

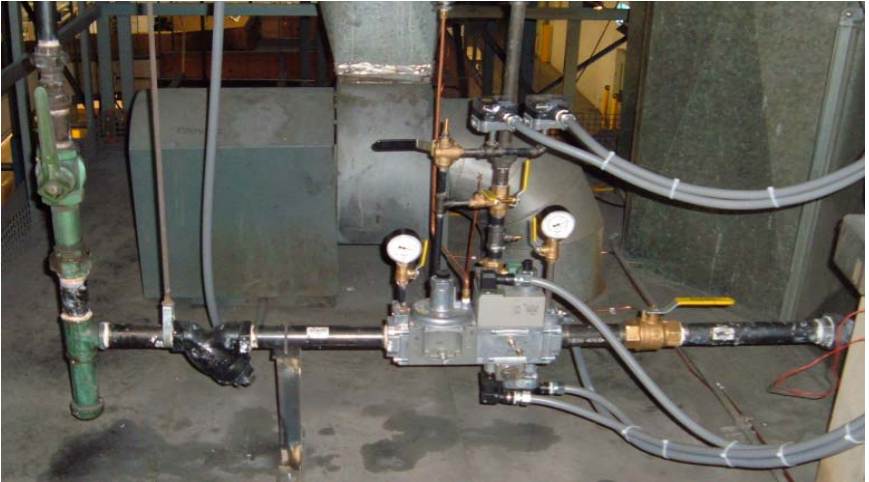
The new simplified modular gas train.

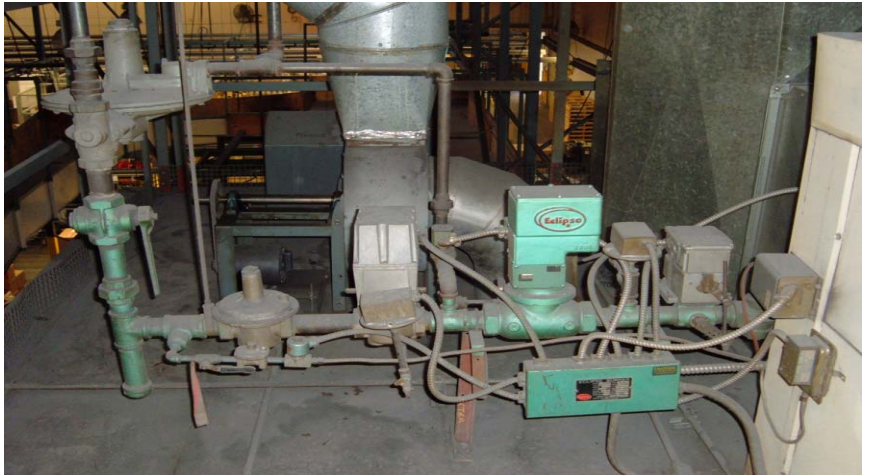
The picture shows the old gas train.
